THE GEOLOGY AND GEOMORPHOLOGY OF THE CORONET PEAK AND ARTHURS POINT LANDSLIDE COMPLEXES.

A thesis
submitted in partial fulfilment
of the requirements for the degree
of
Master of Science in Engineering Geology
in the
University of Canterbury
by
AMANDA JAYNE WILLETTS

University of Canterbury,
June, 2000.

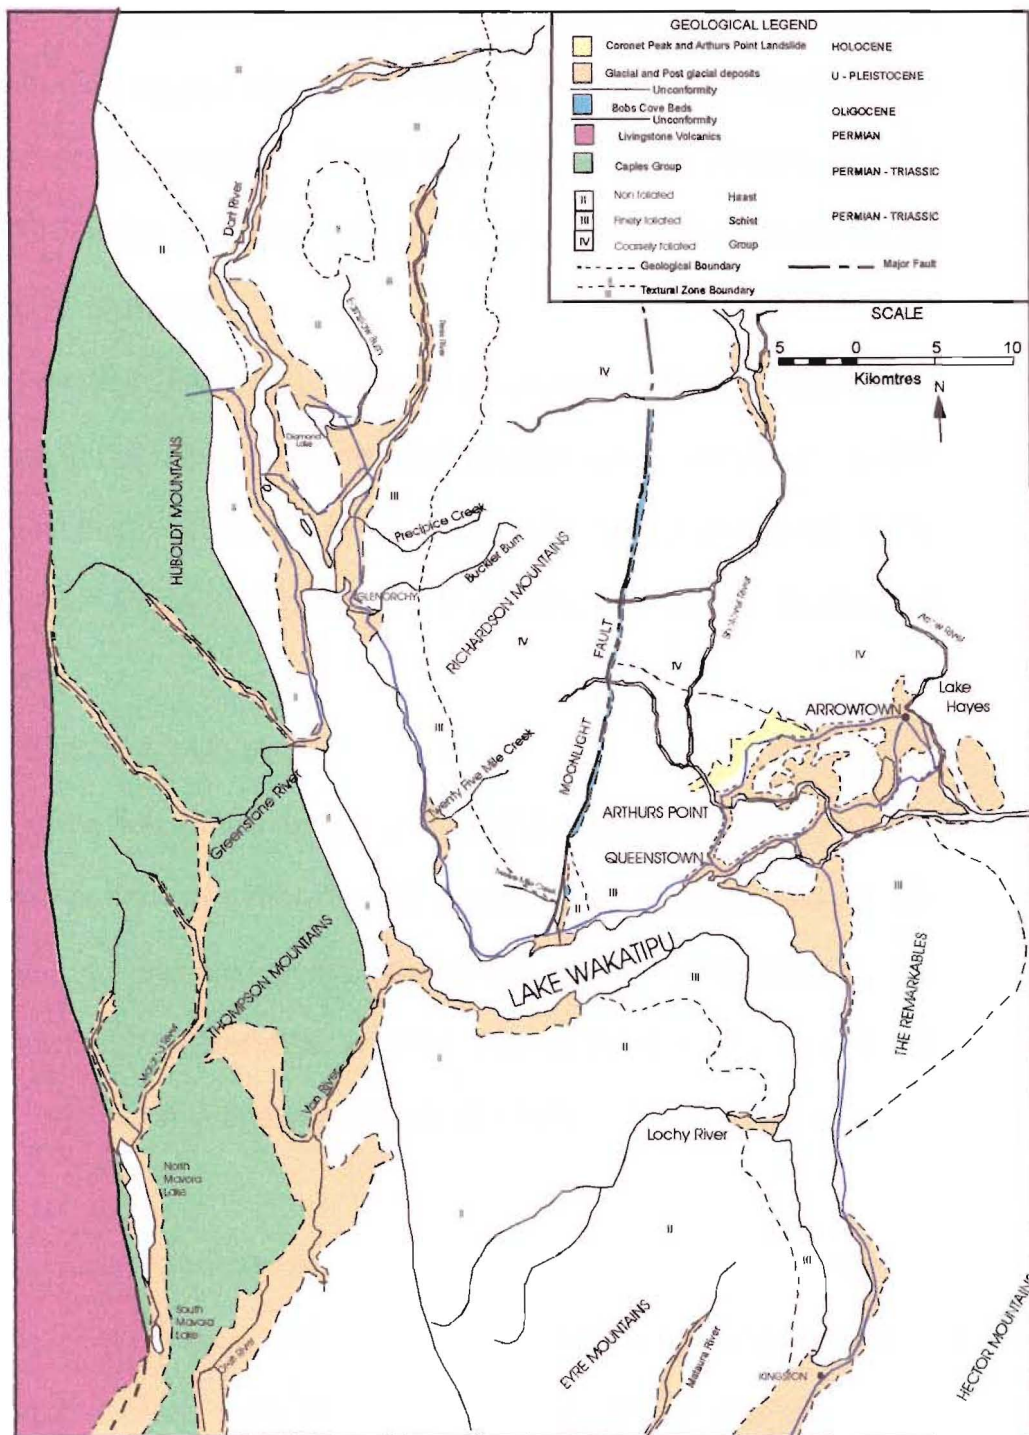
Fig 1.2: A Simplified Geological Map Of The Wakatipu Basin.
(Base map from Watts 1988)

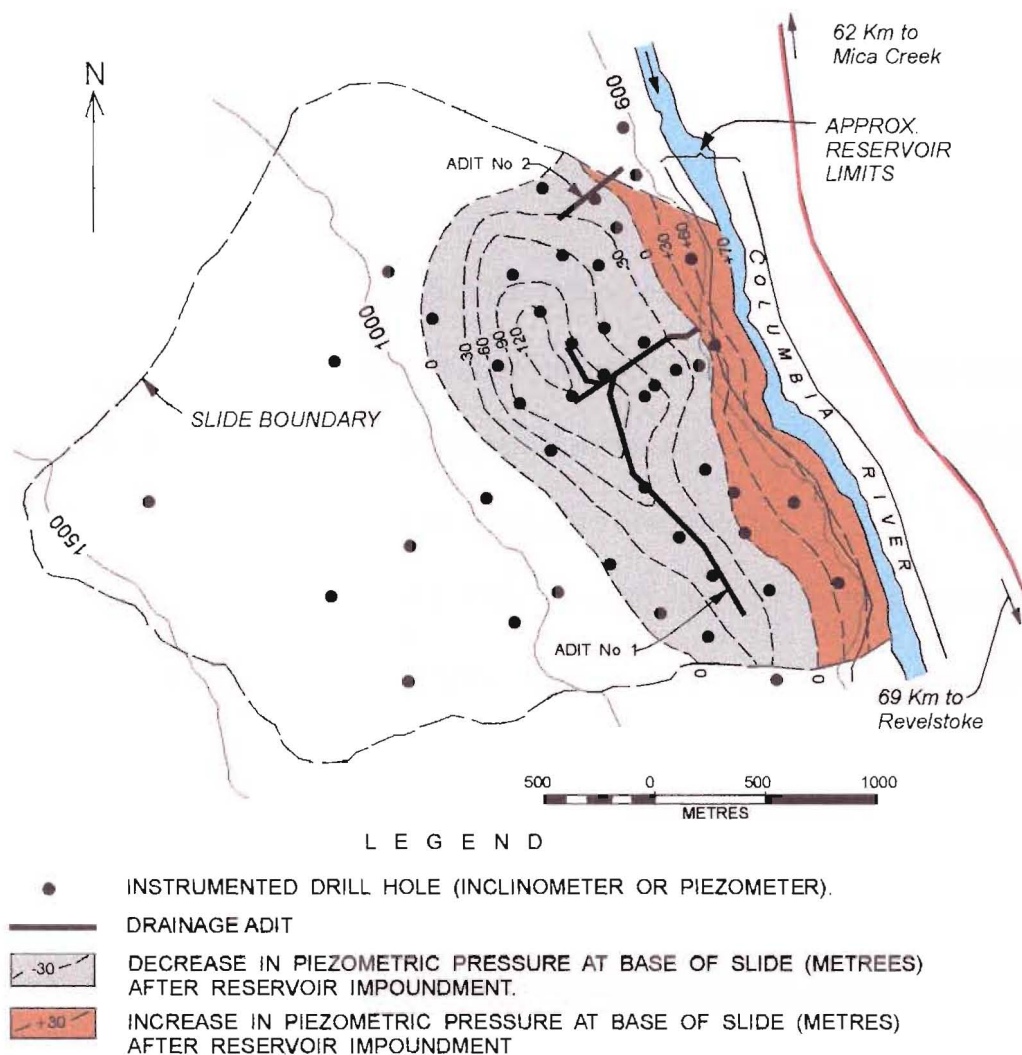
Fig 2.1 (a) : Plan of Downie Slide showing instrumentation array and drainage results. (From Imrie et al 1992).)

A similar situation occurred at Revelstoke Dam in British Columbia, Canada, except that the Downie Slide was the only landslide affected by reservoir filling (Fig2.1). In this chapter the Lake Dunstan landsliding project is covered in detail because it is the most extensive, in-depth investigation of schist landslides in New Zealand and perhaps the world. Other landslides from the Kawarau Gorge and Wakatipu Basin are also covered.

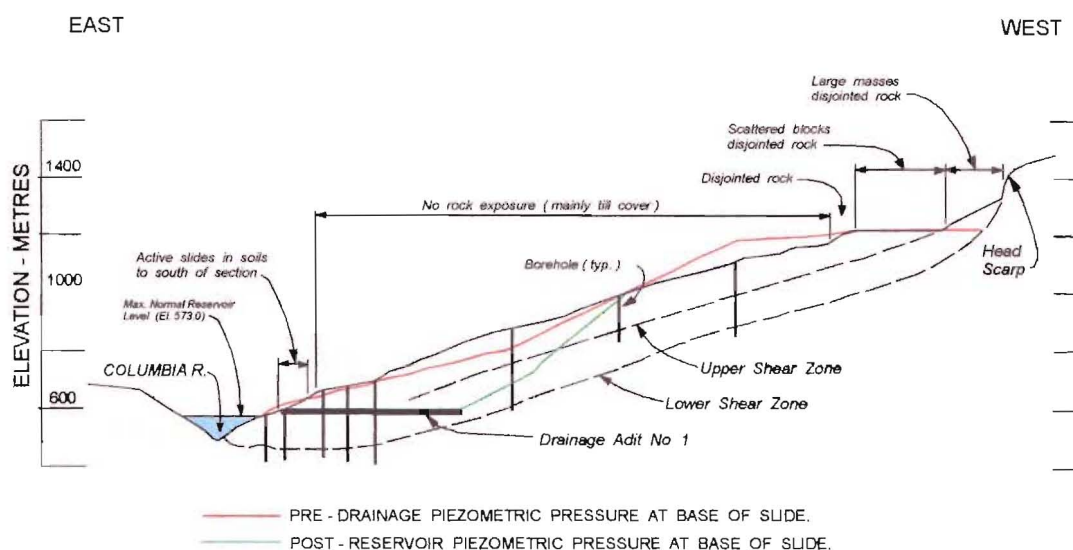
Fig 2.1 (b) : Cross-section of Downie Slide (From Imrie et al 1992).

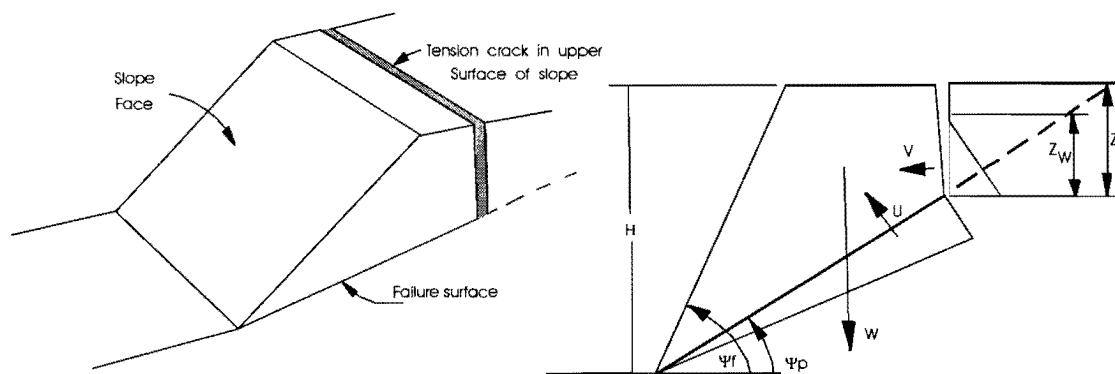
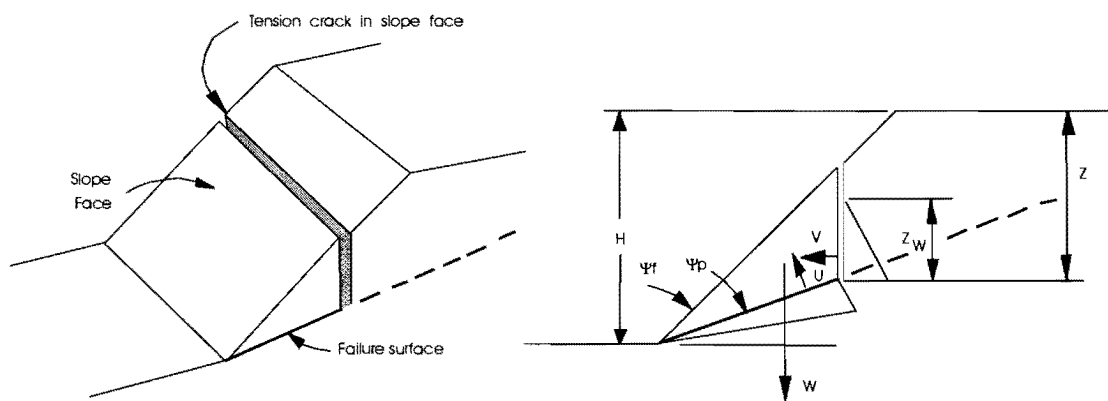
Geometry of slope with tension crack in upper slope surface.

Geometry of slope with tension crack in slope face.

Fig 2.2: Three dimensional drawing of planar failure along a discontinuity that daylight in the slope face (From Hoek and Bray 1981)

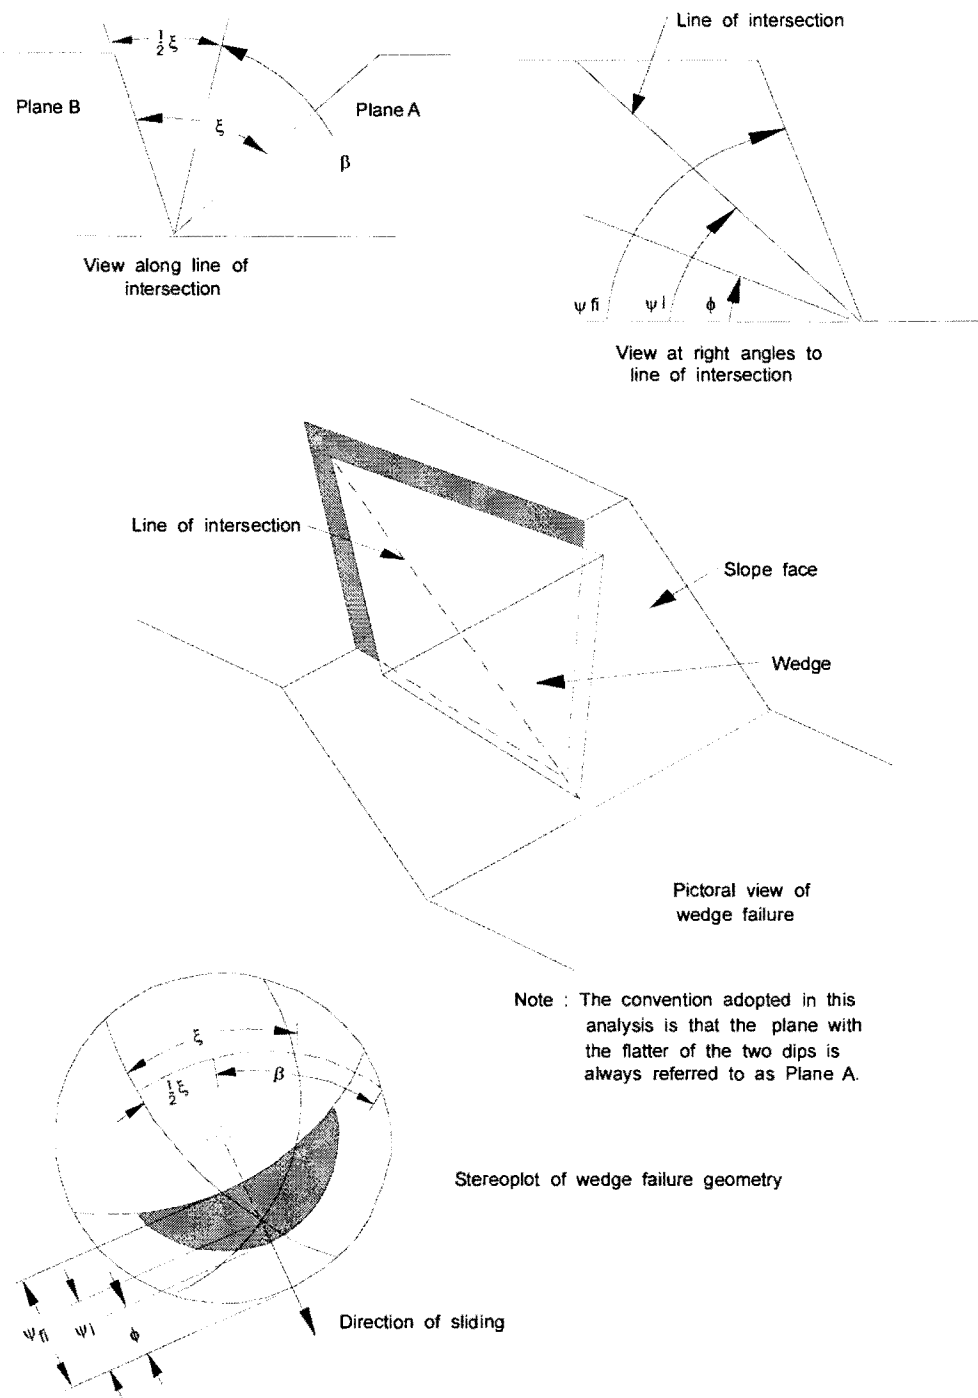
Figure 2.3 : Wedge failure geometry. (From Hoek and Bray 1981)

Wedge failures occur where there is an increasing role of the prominent joint sets, which intersect with the schistosity or other joint sets (Fig 2.3). Fault influence can also occur, such as at the Gibbston Slide (Johnson 1986). Here, a dipslope/wedge failure has occurred between the Gibbston Fault and the schistosity with sliding happening on the fault crush zone surface.

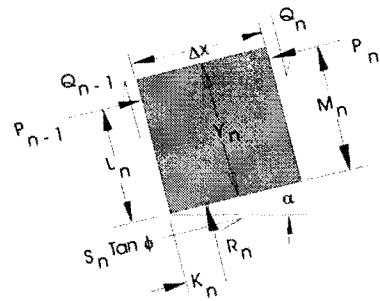
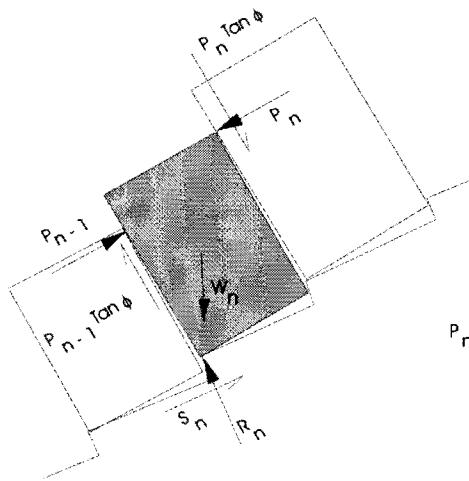
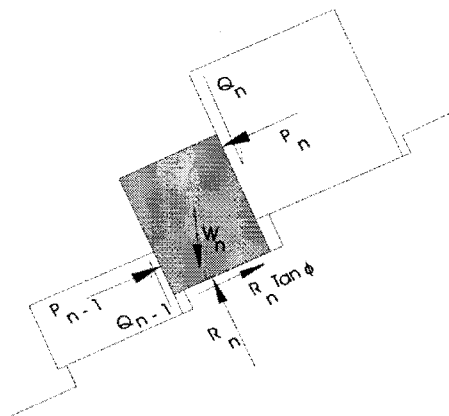
a) Forces acting on nth block

b) Toppling of nth block

$$P_{n-1} = \frac{P_n (M_n - \Delta x \cdot \tan \phi) + (W_n / 2) (Y_n \cdot \sin \alpha - \Delta x \cdot \cos \alpha)}{L_n}$$

c) Sliding of nth block

$$P_{n-1} = P_n \frac{W_n (\tan \phi \cdot \cos \alpha - \sin \alpha)}{1 - \tan^2 \phi}$$

Fig 2.4 Limiting equilibrium conditions for toppling and for sliding of the nth block.

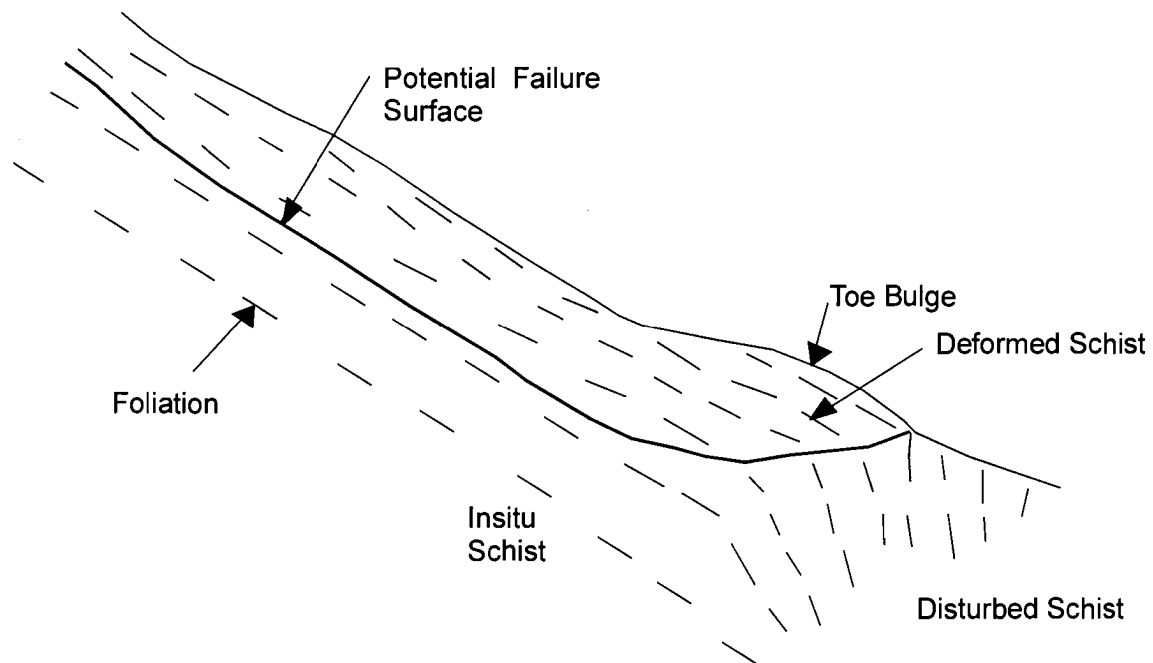
Fig 2.6 a Development of a toe buckling fold due to initial movement downslope to release stress.

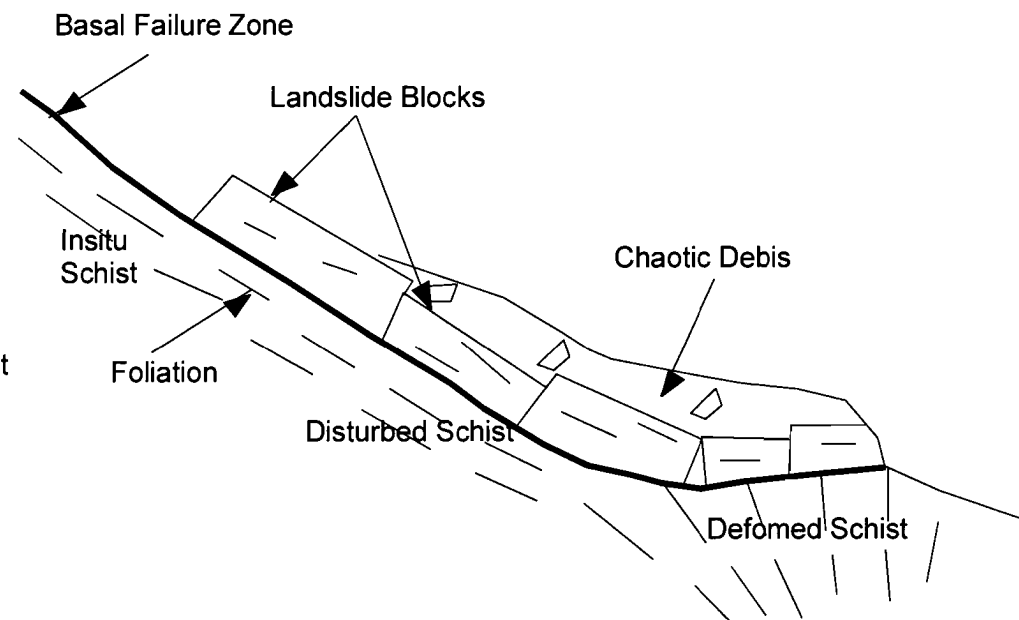
Fig 2.6b Actual failure of the slope, showing the juxtaposition of flat lying schist over near vertical schist.

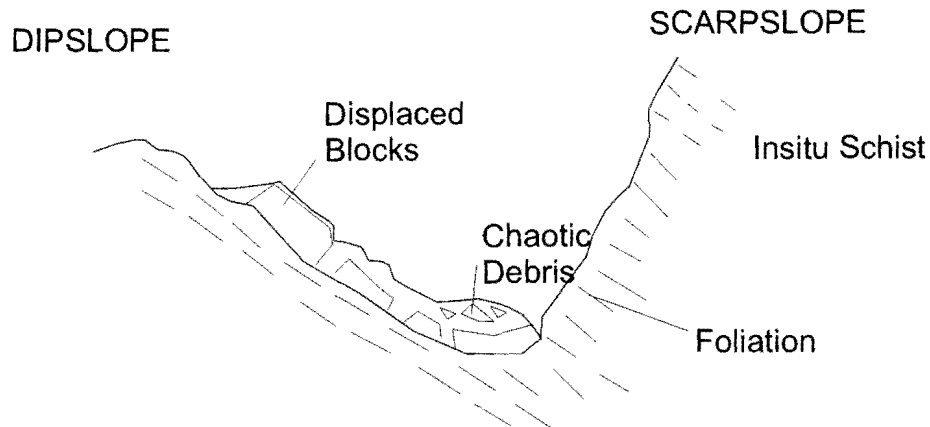
Fig 2.7 Cross-section of an asymmetric profile where sliding has developed.

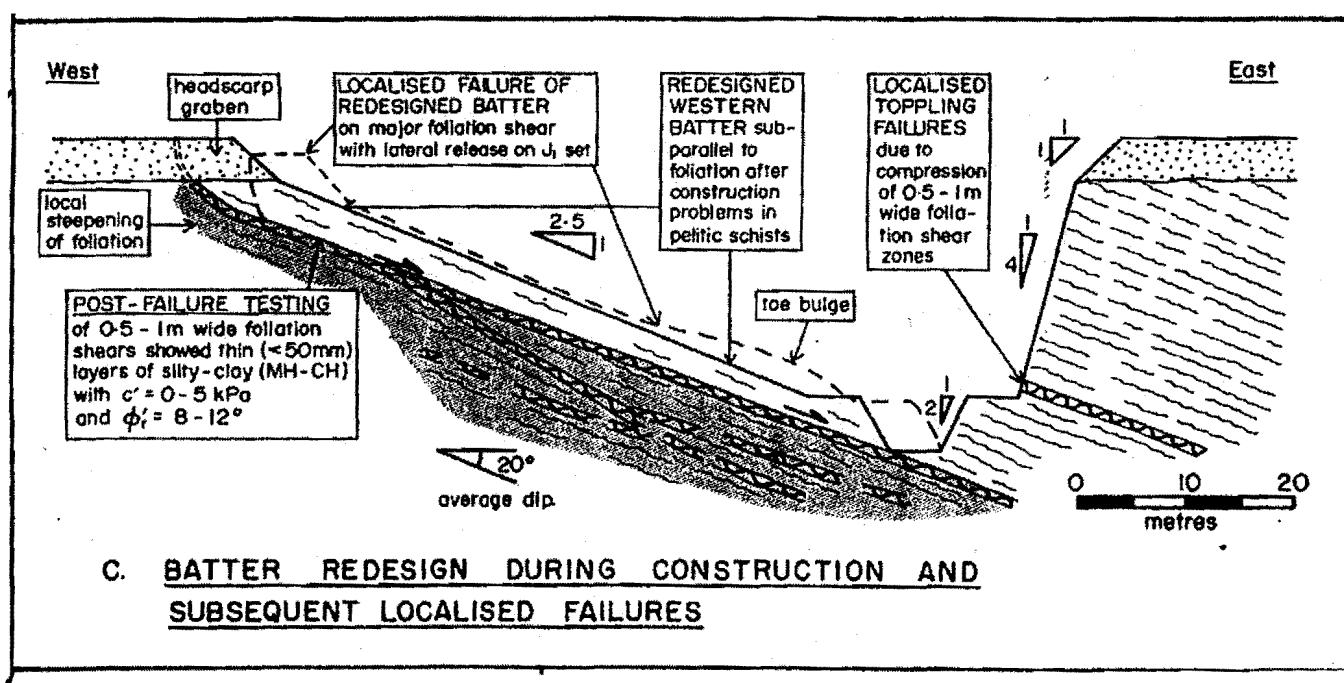
Fig 2.8 Cross-section of the failed batter at Maniototo, showing the asymmetrical profile that was adopted for this project. From Moody (1985).

When the canals were built, the western batter failed along a major foliation shear zone with lateral release on a joint set, after the batter had been redesigned with a gradient close to the dip of the schist foliation (Fig2.8). The batter failed because the foliation dipped into the canal, and the gradient of the batter allowed the foliation shear to daylight in the slope. As the foliation dipped into the slope face on the eastern batter, there was no danger of it failing.

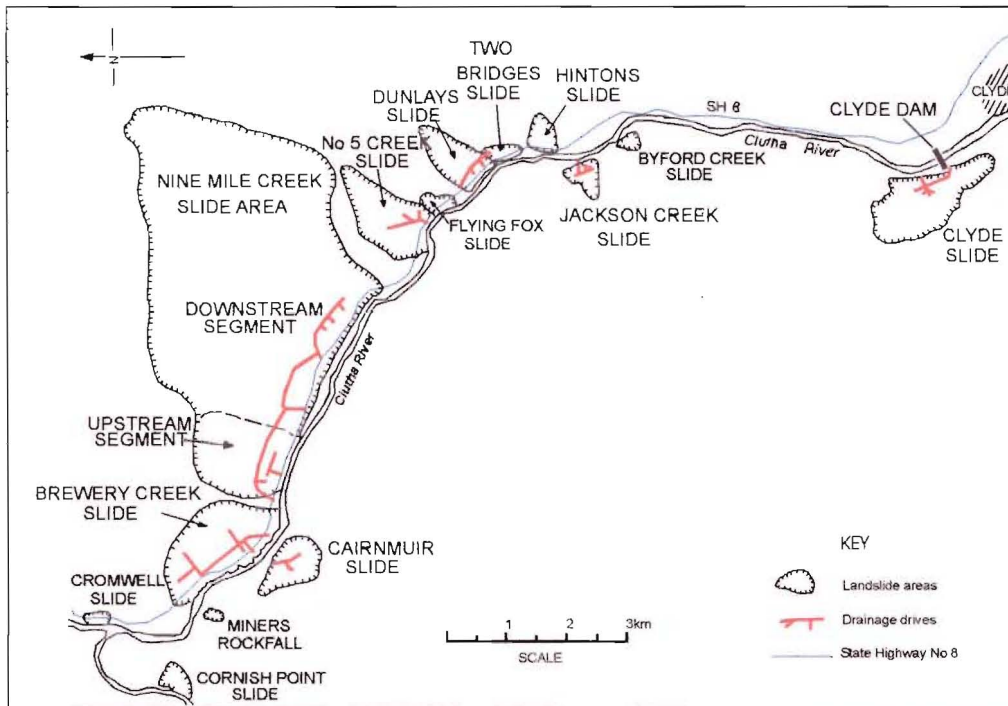
Figure 2.10 Map of the Cromwell Gorge landslide areas showing locations and extent of drainage drives.
(Figure drafted from figure 6, Gillon and Hancox 1992)

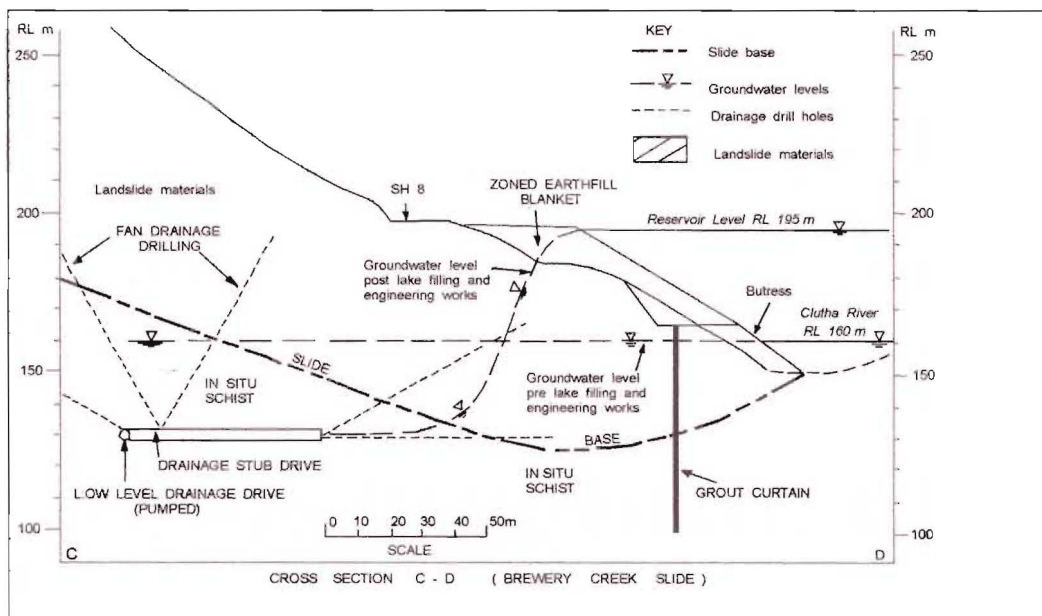
Figure 2.11 Stabilisation by low level pumped drainage, grouting, and blanketing works at Brewery Creek Slide
(Figure drafted from Figure 8, Gillon and Hancox 1992)

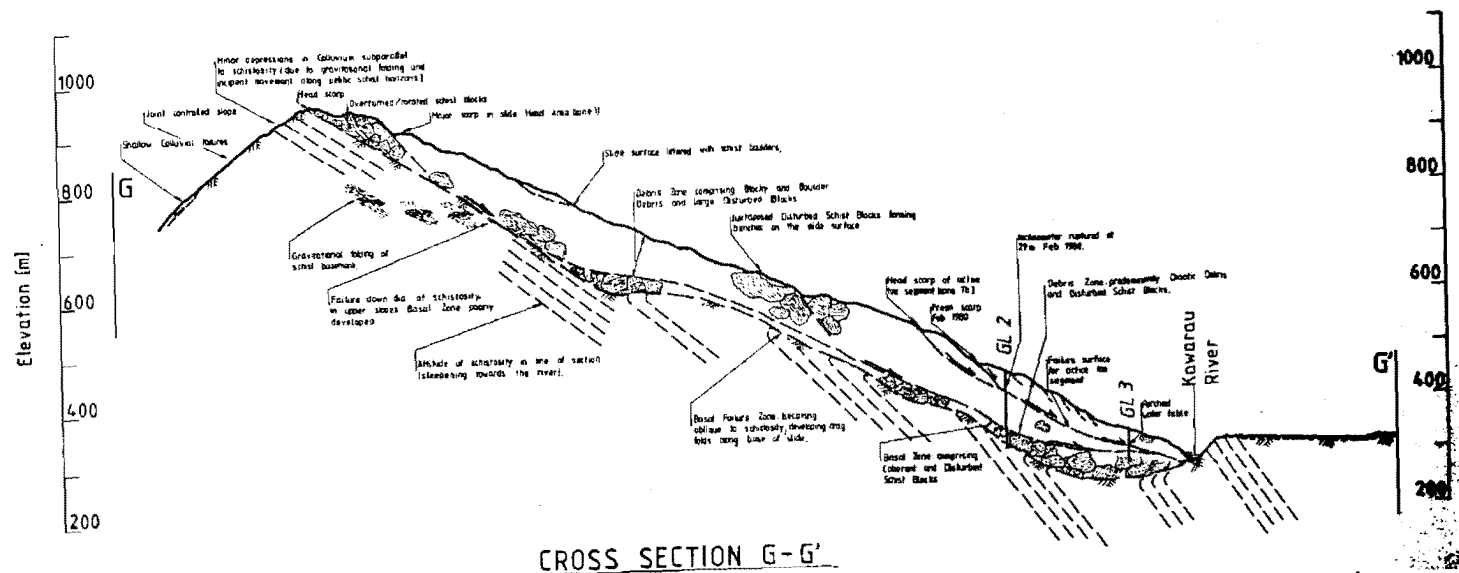
Fig 2.14 Cross-section of Gibbston Slide showing juxtatposed blocks.
From Johnson (1986).

Natural steepening of schistosity downslope (due to the influence of the Mt Rosa Antiform) results in the formation of a convex failure profile. This results in oversteepening of schist blocks with progressive downslope movement, and the tendency for juxtaposed blocks to under or over ride one another (Fig 2.14).

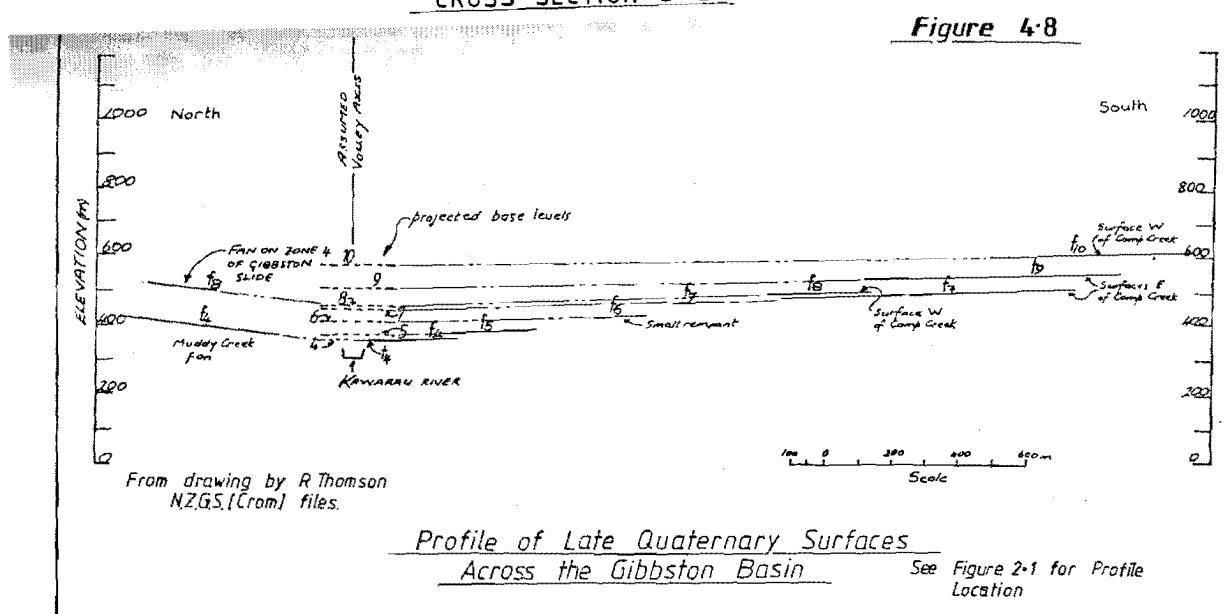
Fig 2.15 Profile of Late Quaternary surfaces across the Gibbston Basin.
From Johnson (1986).

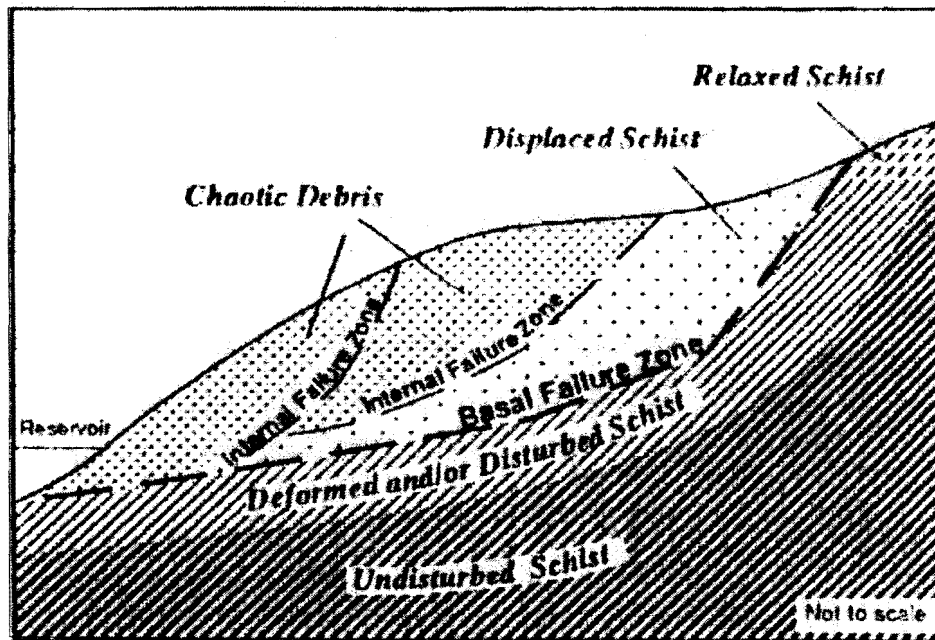
Fig 2.18 Schematic representation of general distribution of slope movement material categories, Cromwell Gorge. From MacFarlane et al (1992).

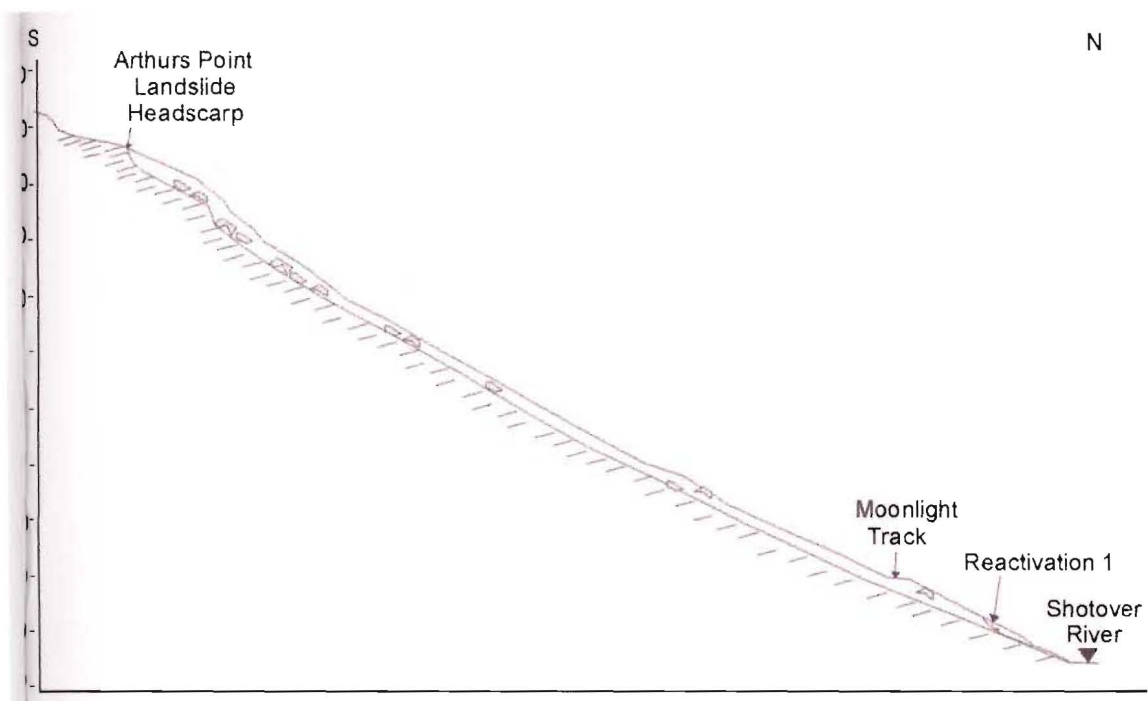
Fig 3.1 Cross-section of Arthurs Point Landslide.

Arthurs Point Landslide is located on the southwest slope of Bowen Peak, and is a wedge failure (Fig 3.1). The toe reaches the Shotover River, but the slide does not extend all the way to the ridge crest of Bowen Peak. It has an area of 0.34km^2 and an estimated volume of $2.4 \times 10^7\text{m}^3$.

With an average slope angle of 40° (ranging from 30° to 45°) the Arthurs Point Landslide is very steep. Elevation ranges from 1360m at the headscarp to 460m at the toe, and the vertical depth perpendicular to the failure plane is estimated to be from 20m to 65m (Fig 3.1).

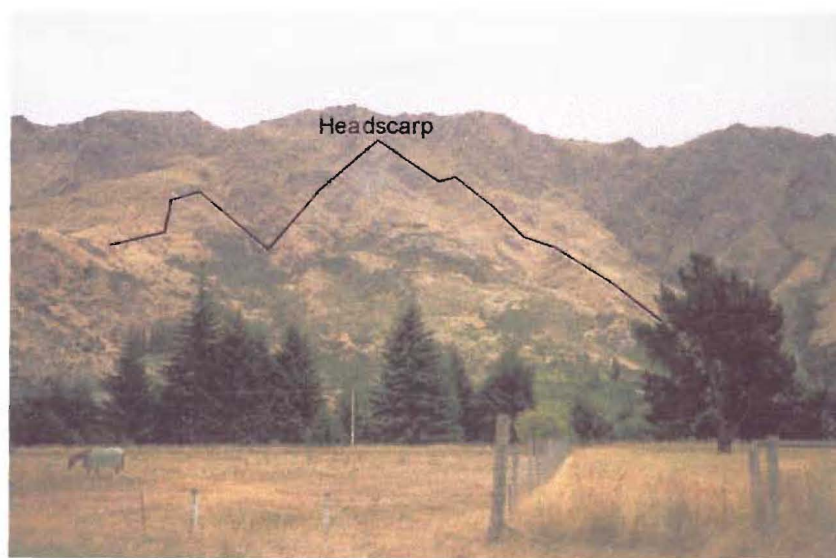
Fig 3.2 Photo showing Arthurs Point Landslides prominent head and lateral scarps.

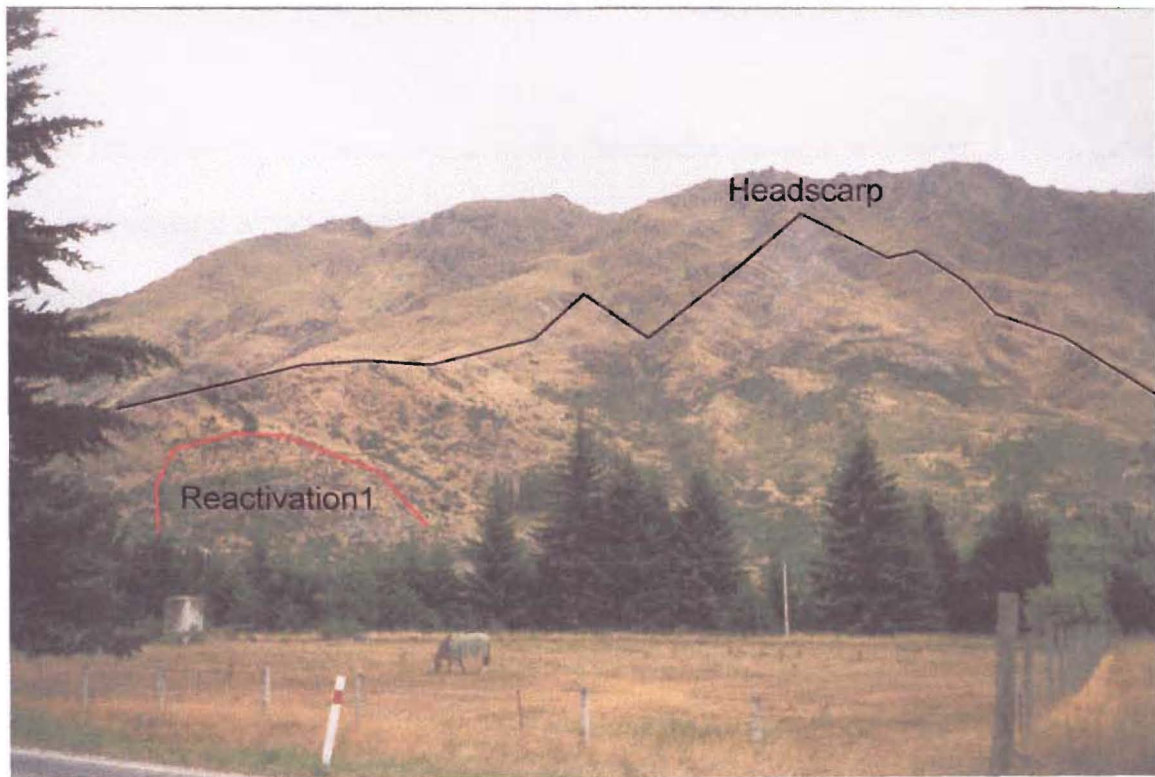
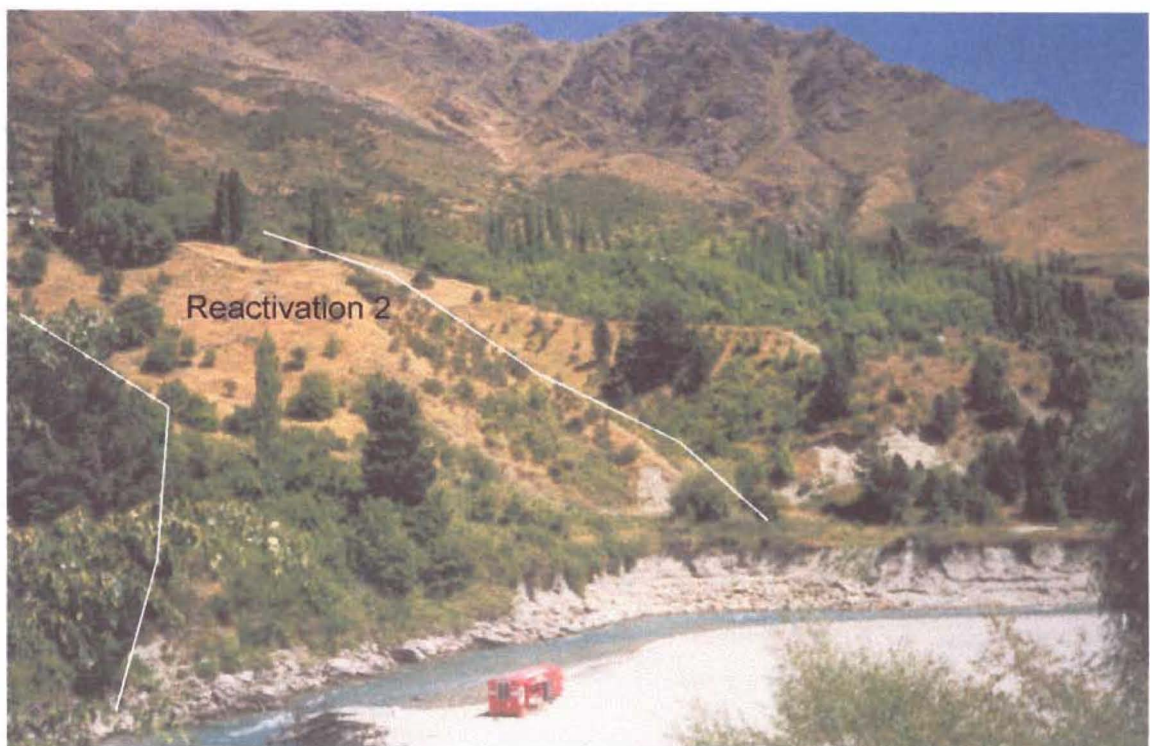
Fig 3.4 Toe of reactivated part of Arthurs Point Landslide.

It is inferred that glacial over-steepening caused initial failure, and then the slide continued to fail retrogressively. Two areas of reactivation are present (Fig 3.3; Fig 3.4; Fig 1.6a-map pocket), associated with incision of the Shotover River into the toe of the landslide (possibly about 5000 years ago or less).

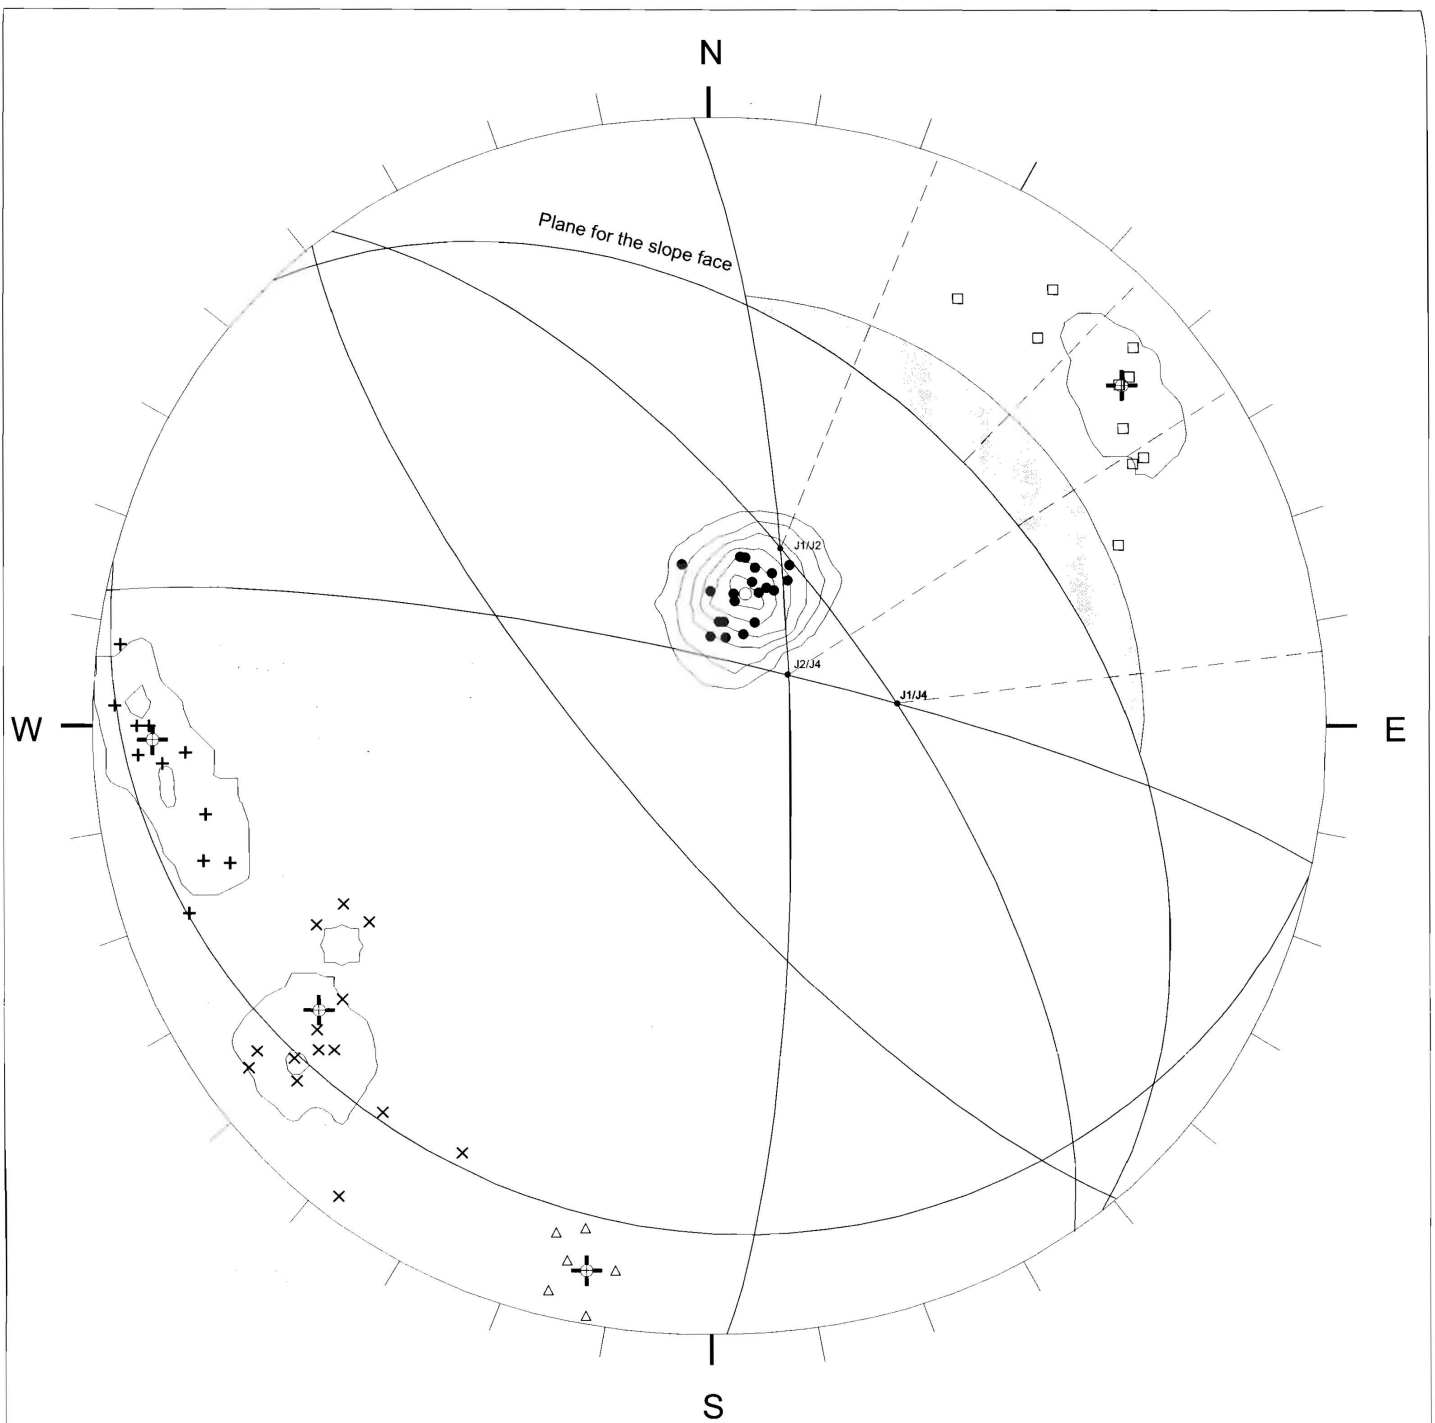
Three intersections of joint sets forming possible failure planes can be seen in Fig 3.5. The trends of the intersections are; $J1/J2=022$, $J2/J4=057$ and $J1/J4=084$.

- Poles For Foliation
- × Poles For Joint Set 1
- + Poles For Joint Set 2
- Poles For Joint Set 3
- △ Poles For Joint Set 4
- Poles For Planes
- Friction Angle (30°)

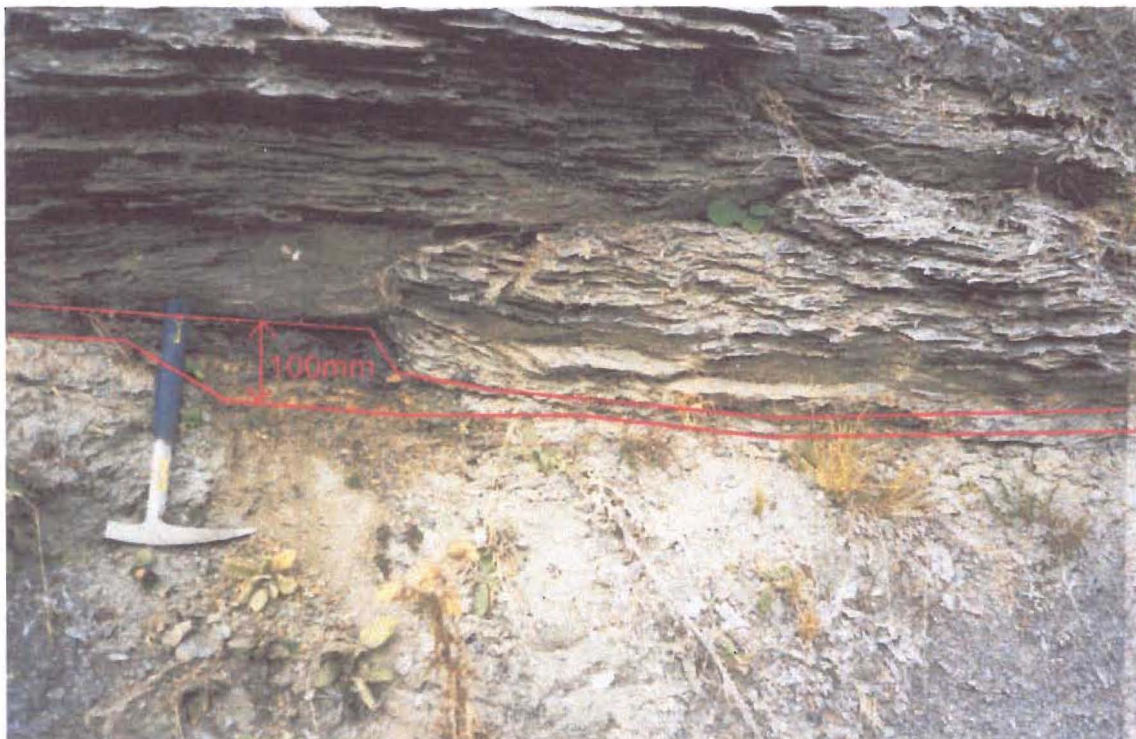
Fig 3.7 Photo showing foliation shear zone located near Coronet Peak Landslide.

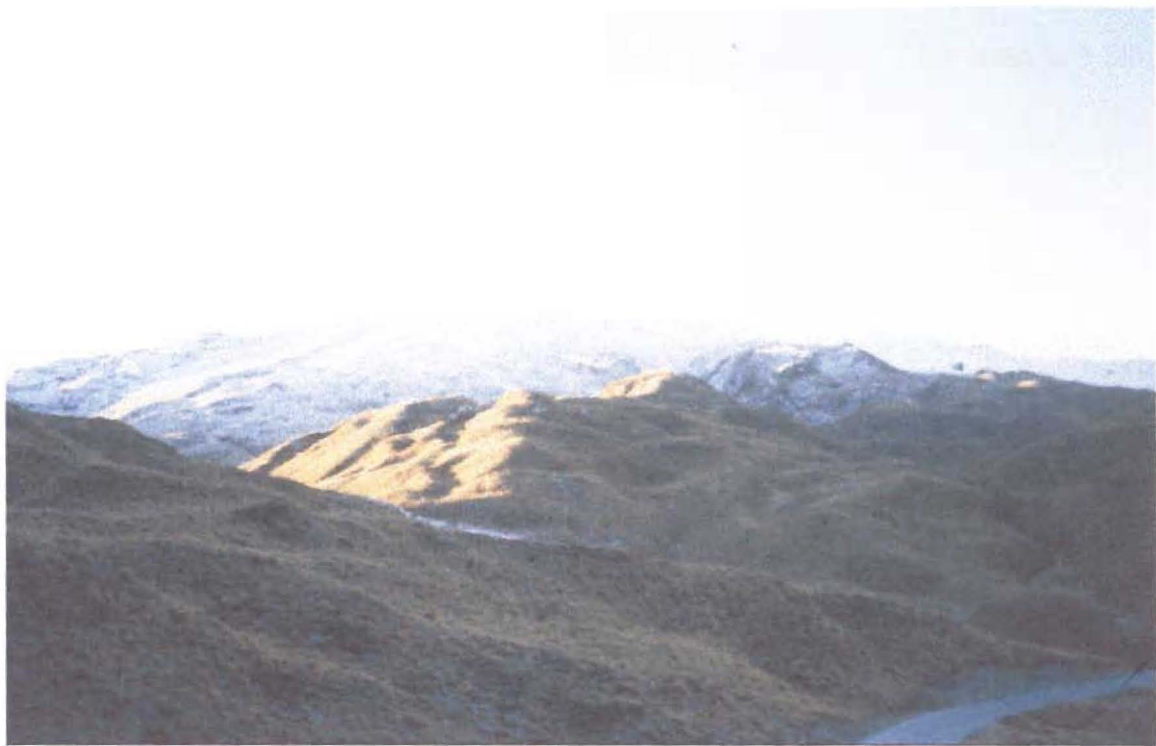
Fig 3.9 Hummocky topography of the Coronet Peak Landslide

This probably at a slower rate than seen at Cromwell Gorge, as there is no form of toe support removal (e.g. a river, another landslide, a glacier). At Coronet Peak Skifield there has been no noticeable movement of any of the pillars that support the skilift over a time period of 50 years.

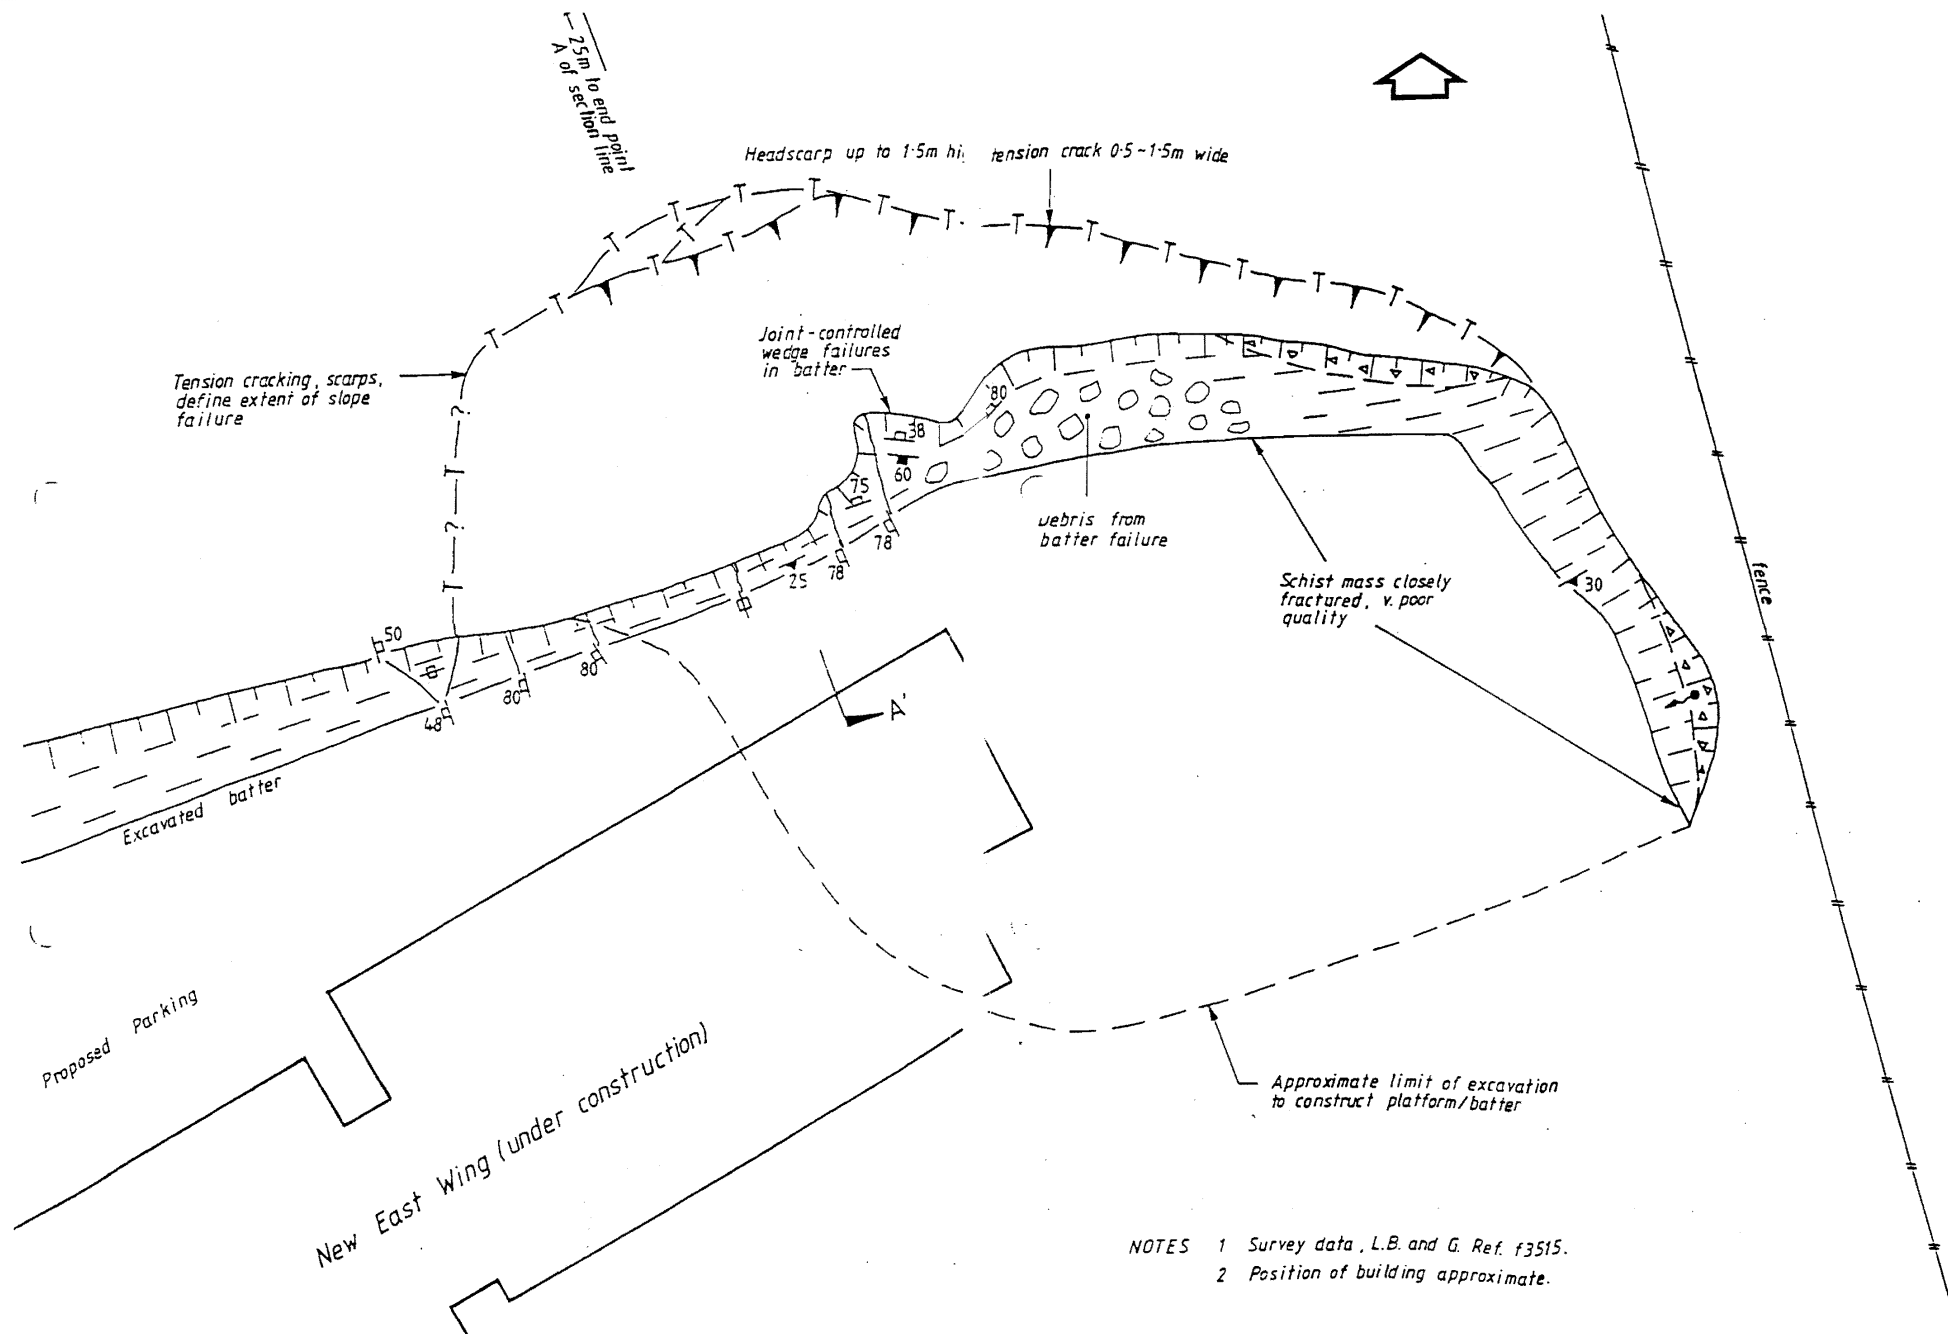
Fig 4.3 Plan Of Coronet Plaza Wedge Failure
